# Manhole Inspection Summary

Manhole # S37G\_\_045MH

Insp Date: 1/14/09 9:23 AM

**Location** Address: **44 south st**

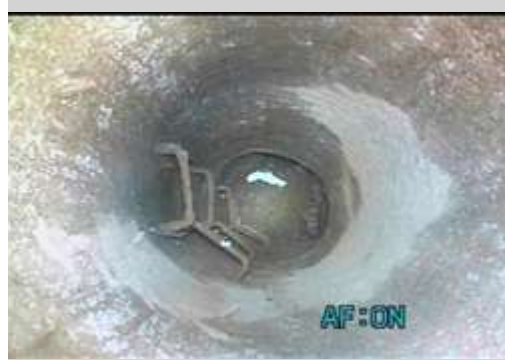
Top View

cant see channels from top

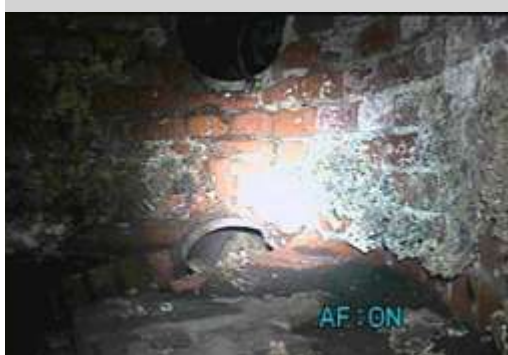
Defect 5

☒ **Evidence Of Surcharge** Depth: **3** (ft.) ☐ Active Surcharge Present

Evidence of surcharge- grease/debris on walls

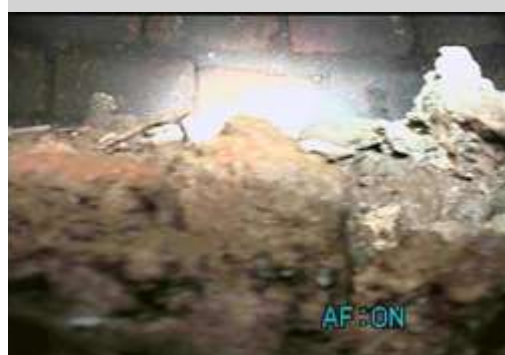
Defect 4

Condition: ☐ Sound ☐ Cracked ☐ Root Intrusion ☐ Deteriorated ☐ Leaks ☒ **Debris**

bench debris

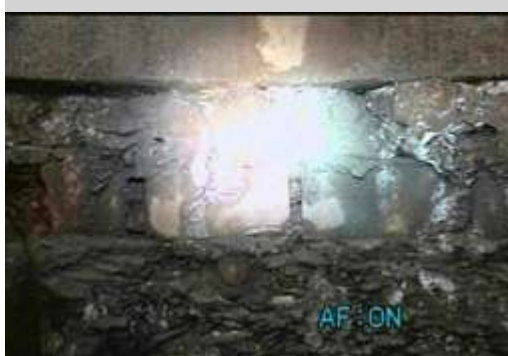
Defect 3

Condition: ☐ Sound ☐ Cracked ☐ Root Intrusion ☐ Loose Brick ☒ **Deteriorated**

corbal

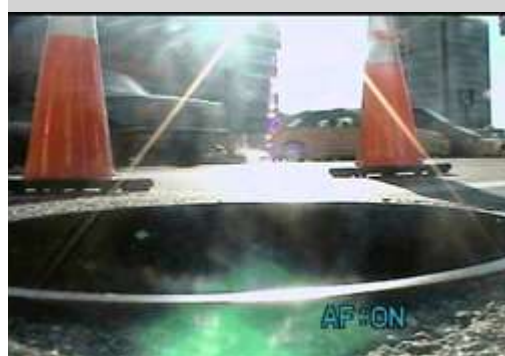
Defect 2

Diameter: **26** (in.) Length: **0** (in.) Dist A/B Grade: **1** (in.)

above grade

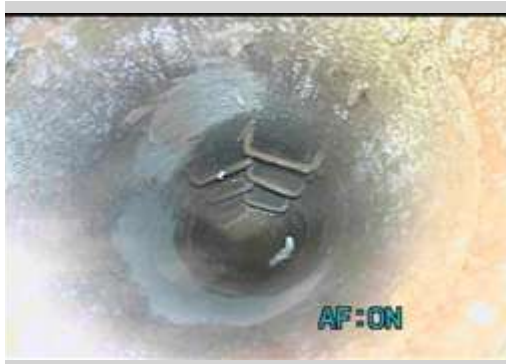
### Defect 1

Count: **10** Missing: **2** ☒ **Corroded**

corr steps
